WESTERN TECHNOLOGIES INC.

RE: PRELIMINARY ASBESTOS SURVEY OF THE COTTON AND WATER RESEARCH LABORATORIES IN PHOENIX, ARIZONA. WT JOB NO. 7130K042.

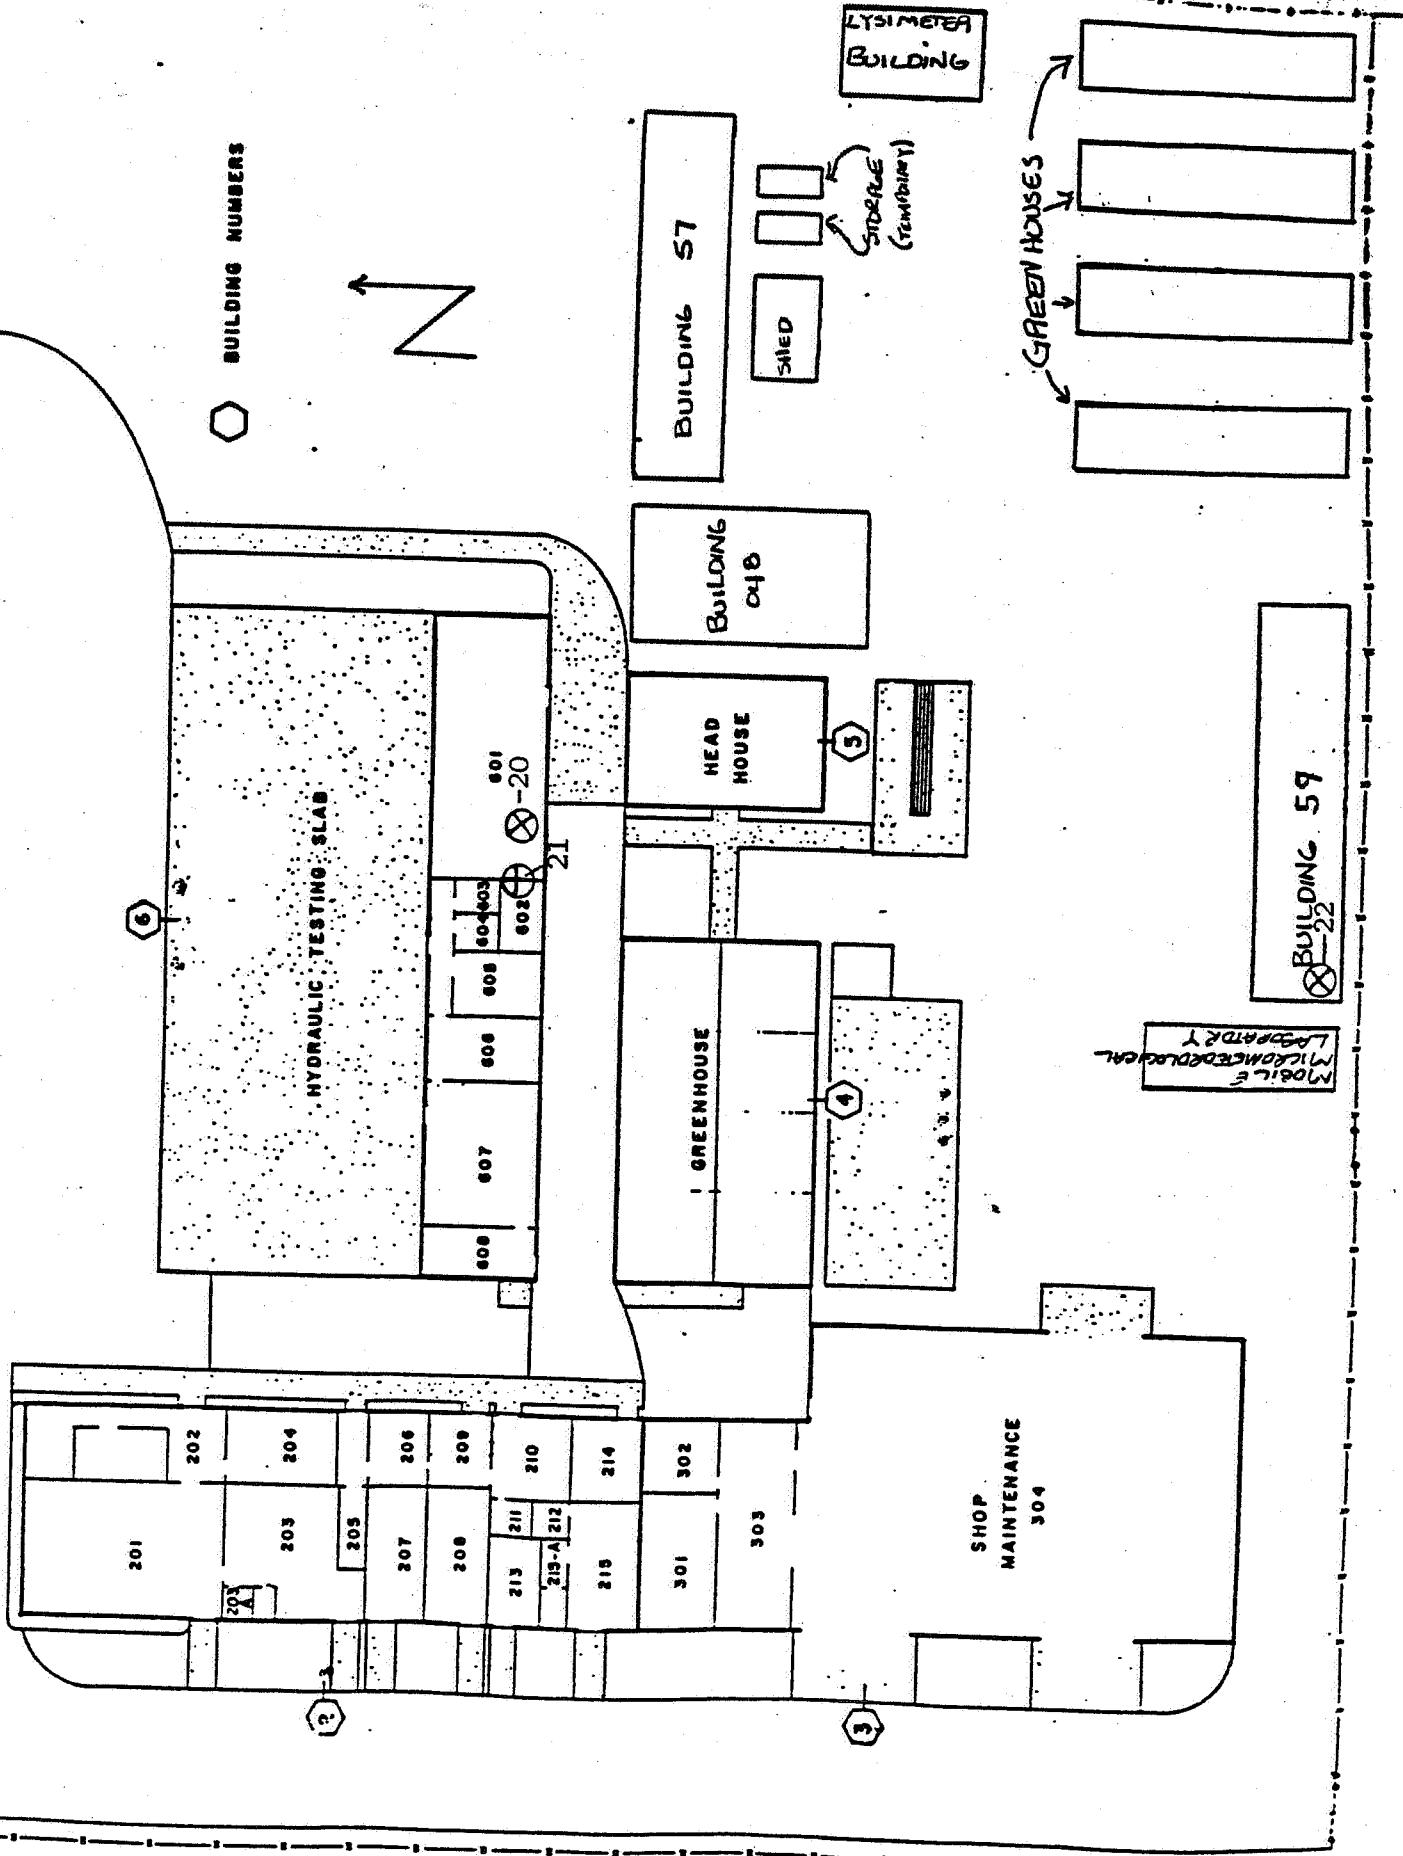
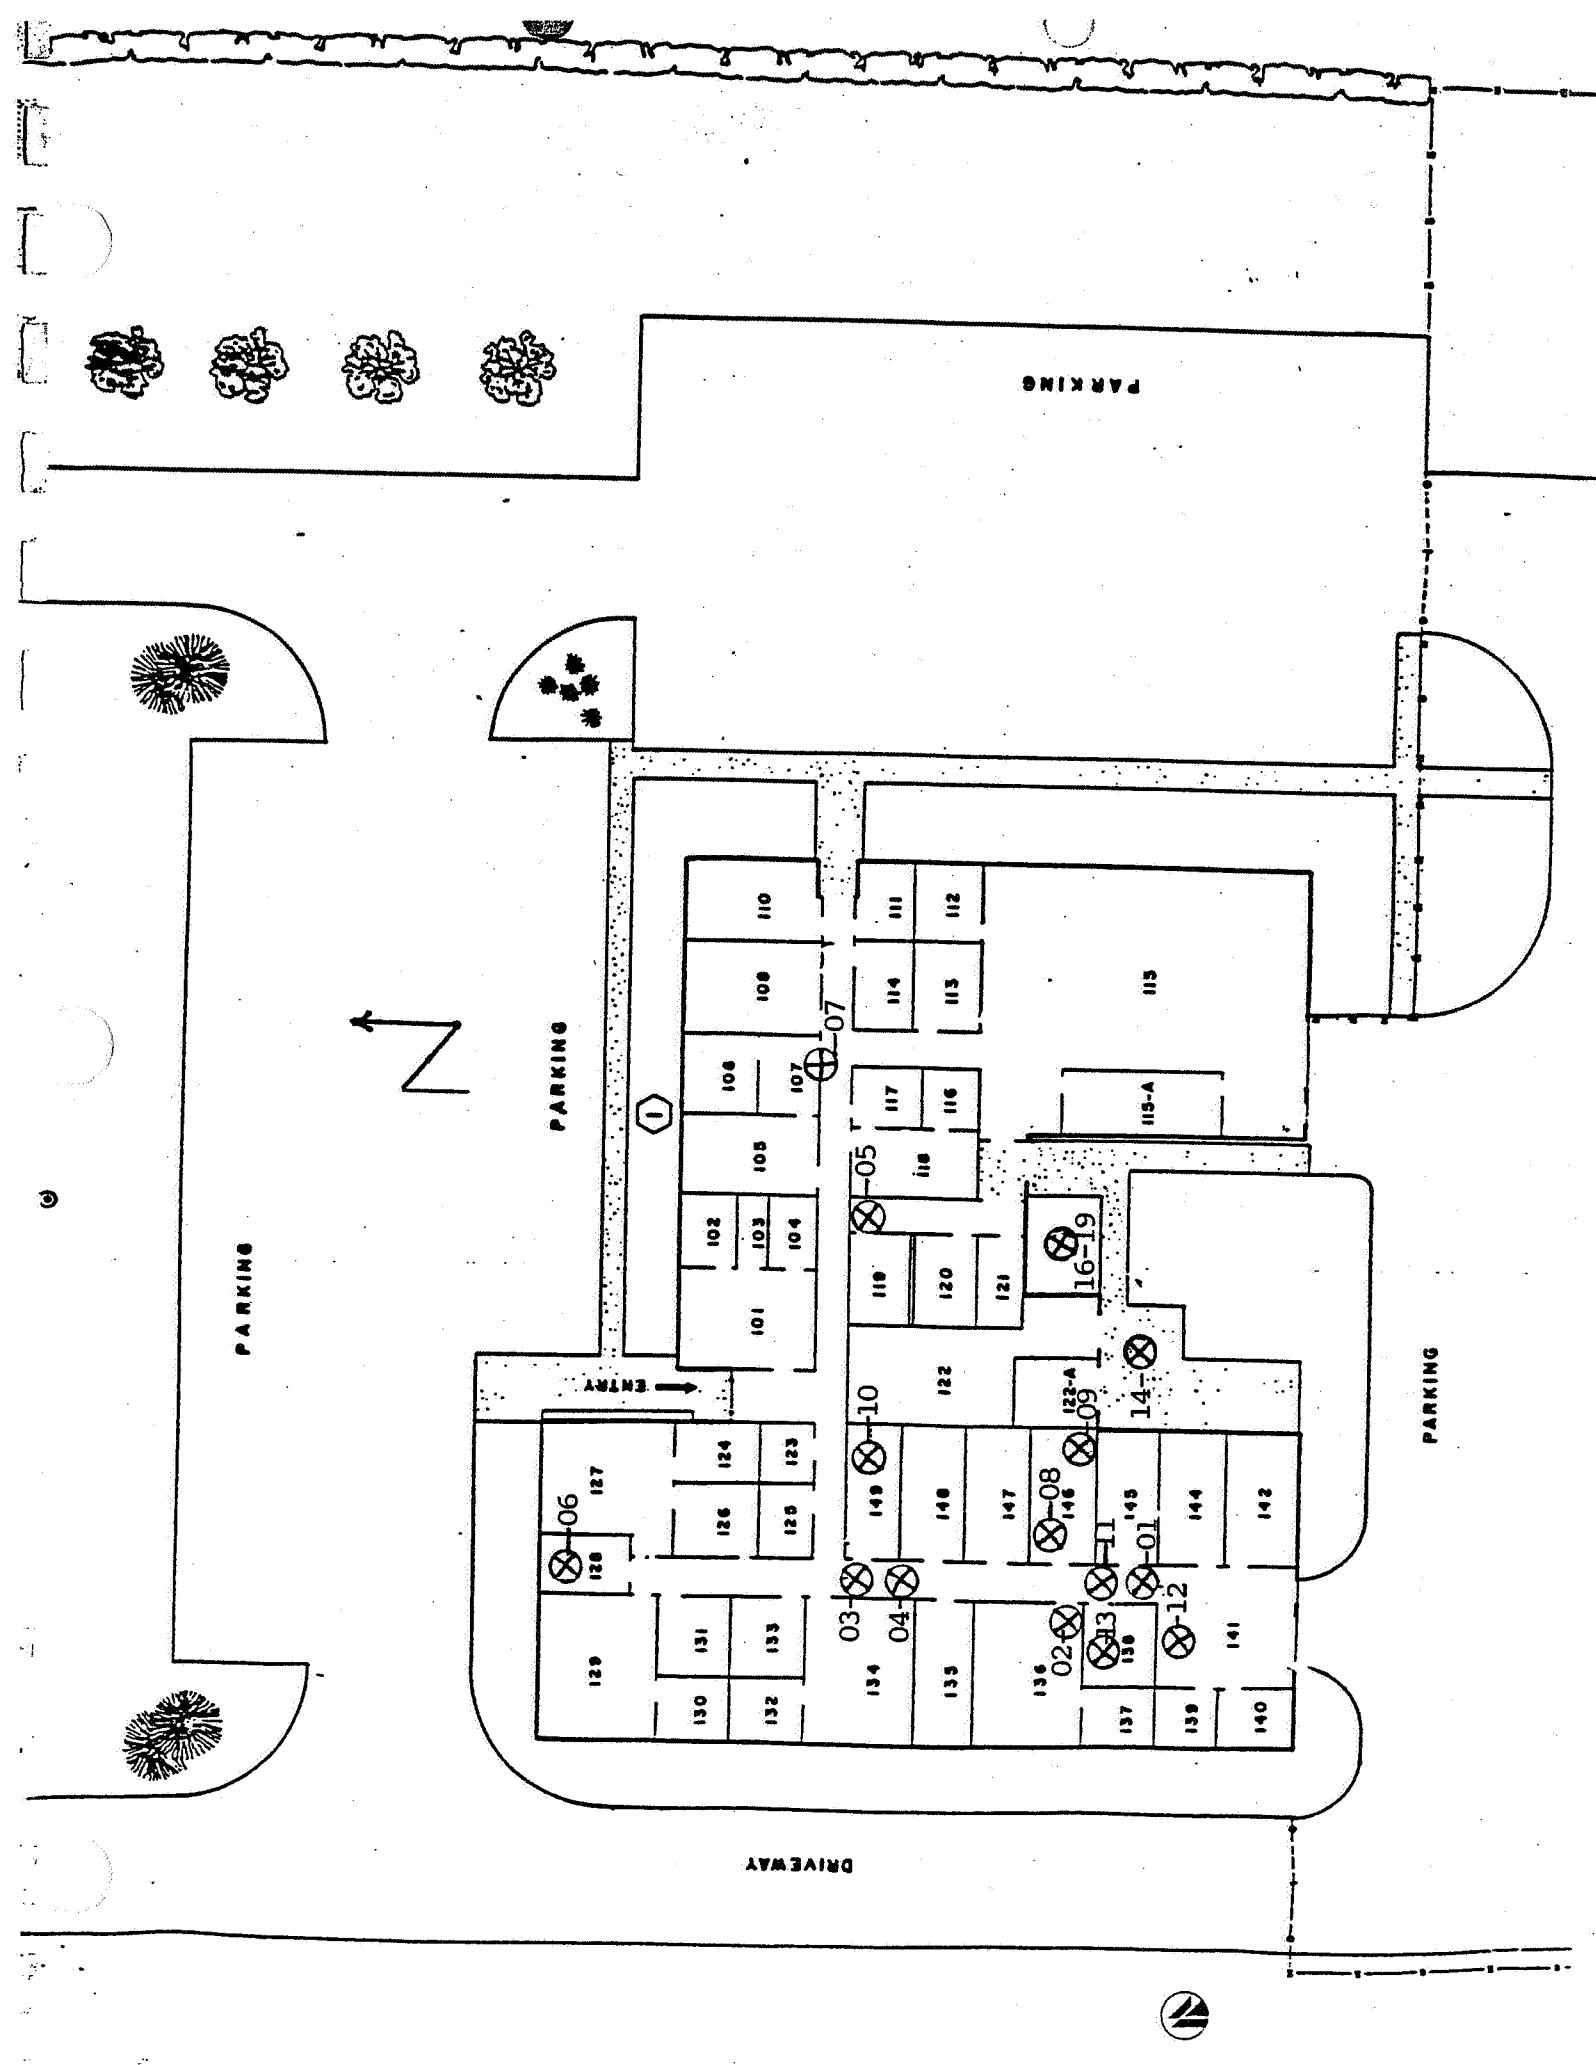
A summary of the materials found to contain ACMs, estimated quantities, and estimated costs for removal are presented along with sample location plans in Appendix C. The quantities of sampled materials are only estimates. Accordingly, variations in quantities of ACMs are possible.
